2020 GMC Technical bulletin #161 (Radio HVAC IPC blank out when operating a Snowplow)2

Subject: Intermittent Cluster, Radio and HVAC Display
Resets on Snow Plow Trucks

Models/Years 2020 – beyond Chevrolet Silverado 2500-3500 HD

Affected: 2020 - beyond GMC Sierra 2500-3500 HD
With Snow Plow Prep Package (RPO VYU)

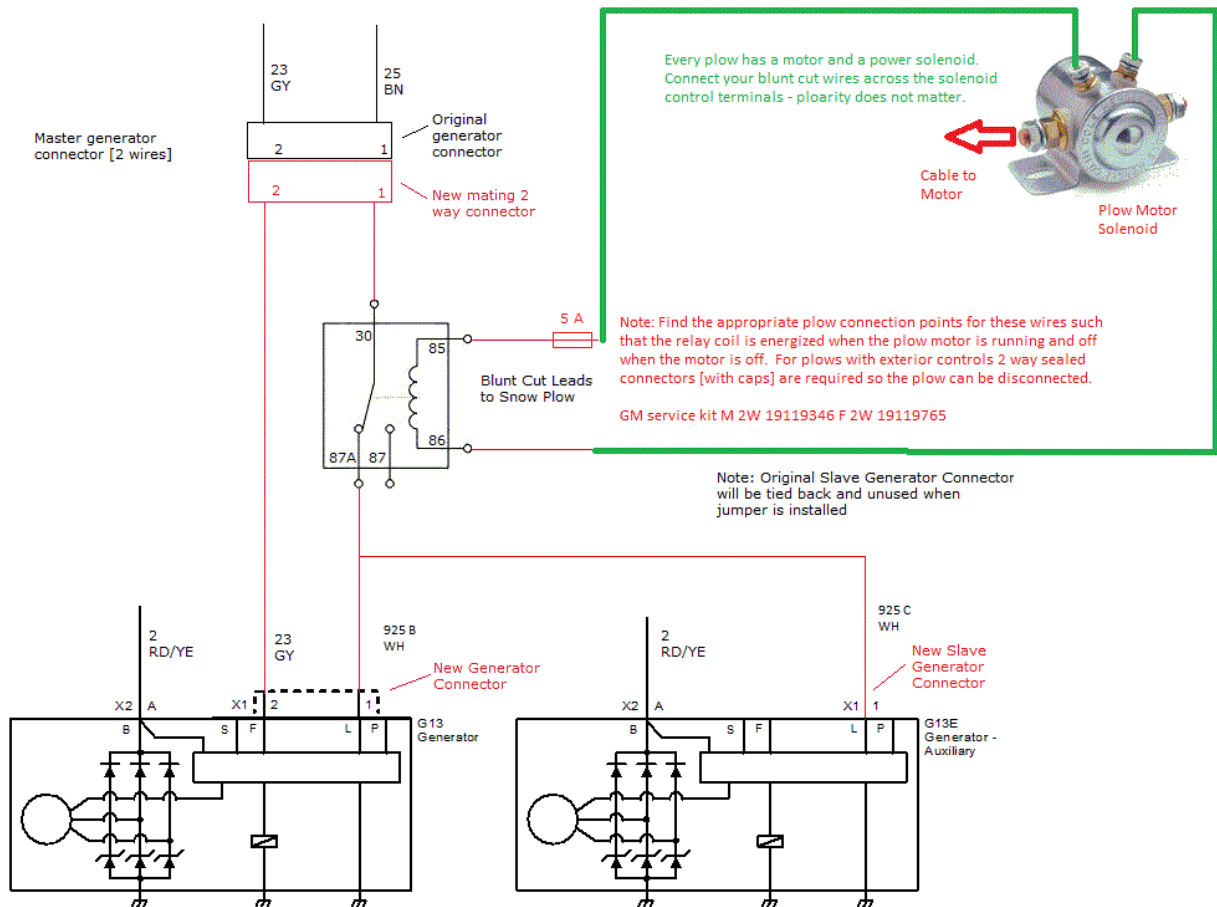
Fig 1: Jumper harness wiring schematic

VYU Service Harness for both single and dual generator trucks

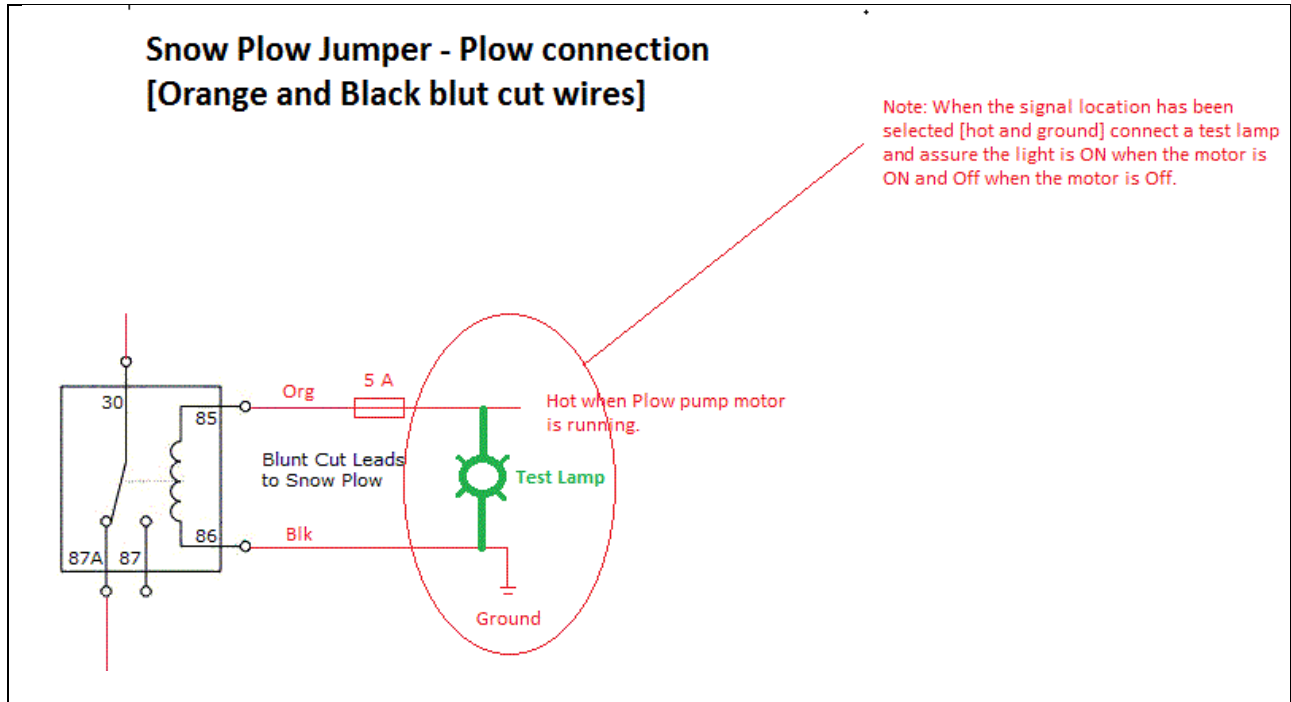
Note: To identify the signal needed by the jumper harness perform the following test. Any connection point that passes this test can be used. The best case is a signal from the wiring that remains with the truck but if that is not found then the signal must be found out on the plow itself.
