2020 GMC Technical bulletin #161 (Radio HVAC IPC blank out when operating a Snowplow)2

Subject: Intermittent Cluster, Radio and HVAC Display
Resets on Snow Plow Trucks

Models/Years 2020 – beyond Chevrolet Silverado 2500-3500 HD

Affected: 2020 - beyond GMC Sierra 2500-3500 HD
With Snow Plow Prep Package (RPO VYU)

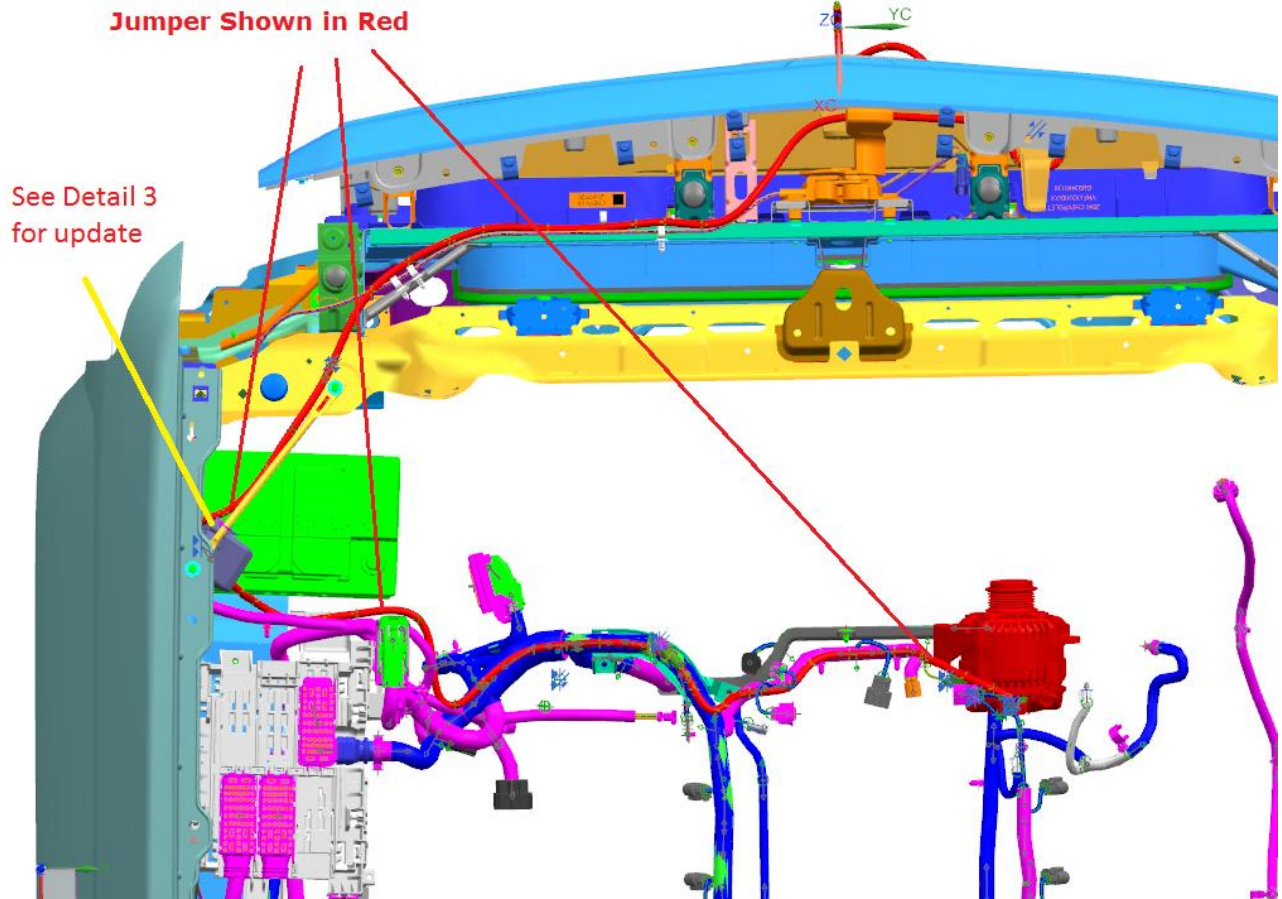
Fig: 3a Jumper Harness Layout – single alternator [see detail 3 for updated relay mounting]

VYU Single Alternator - Jumper Harness

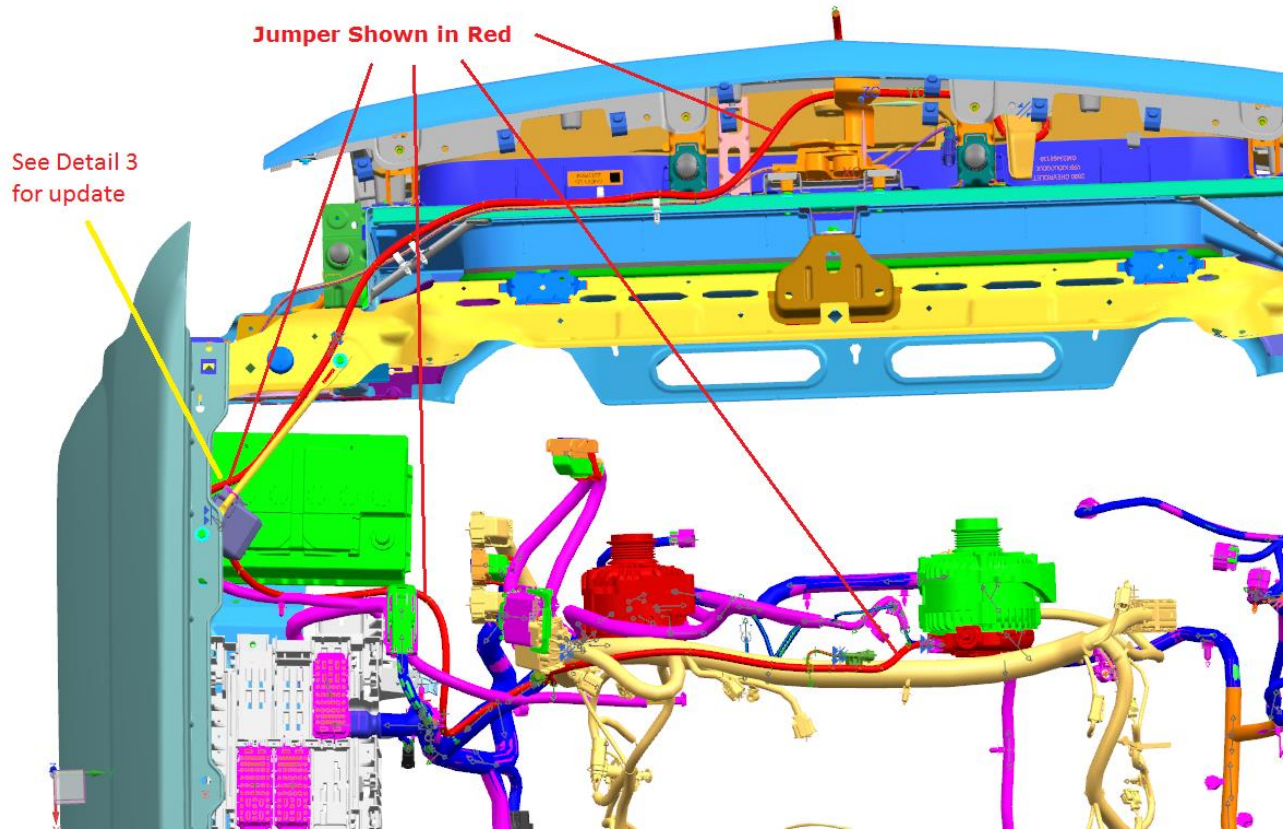
Fig: 3b Jumper Harness Layout – dual alternator [see detail 3 for updated relay mounting]

VYU Dual Alternator - Jumper Harness

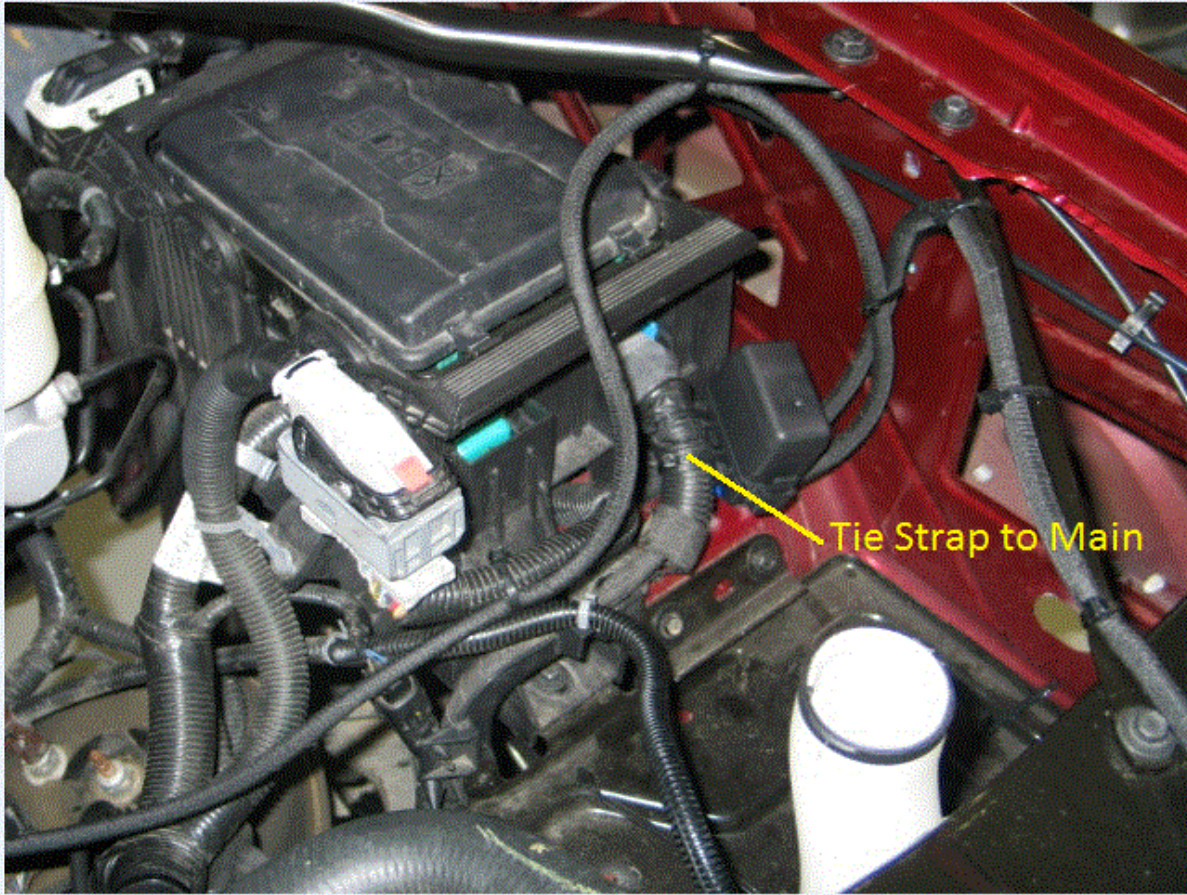
Detail 3.1.2

Single Battery Trucks

- i) Route the snow plow jumper harness along the existing harness routing where possible and secure the relay center with tie straps as shown in Details 3.1.1-3. Allow slack for engine roll and upright orientation of the relay center to prevent water intrusion/collection.

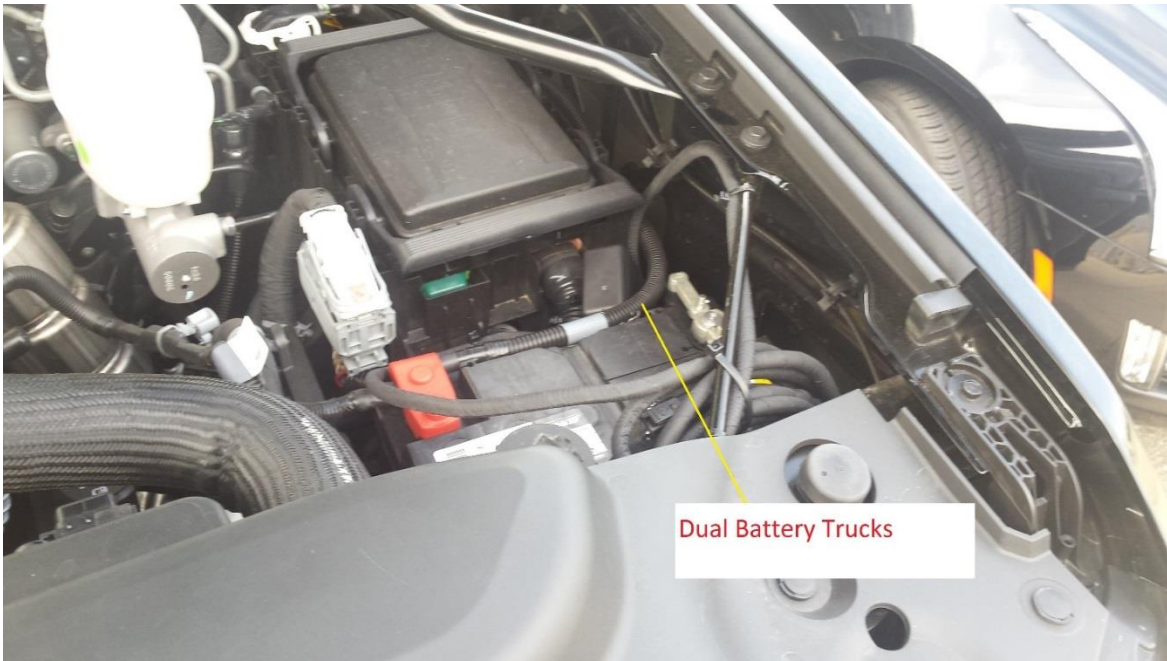
Detail 3.1.3

Dual Battery Trucks
